DENTAL IMPLANTS

A Practitioner's Perspective

Case Study No. 1 - Working below the sinus floor - Geoff Pullen

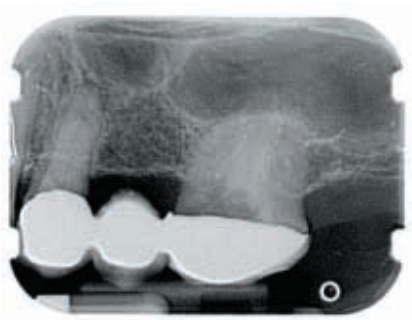
2

There should be plenty of bone for an implant at the pontic site should we choose and that molar must be in plenty of bone. But the socket is large and needs some healing before we can place an implant.

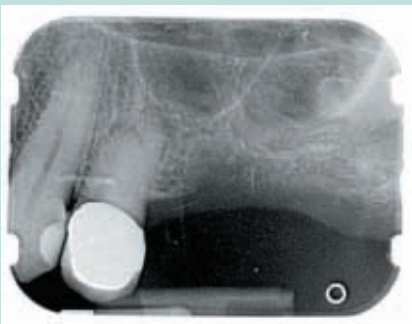
3

It doesn't look so clever on this radiograph taken 8 weeks after the extraction but there was bony height when the tooth was there so we couldn't have lost that much on extraction.

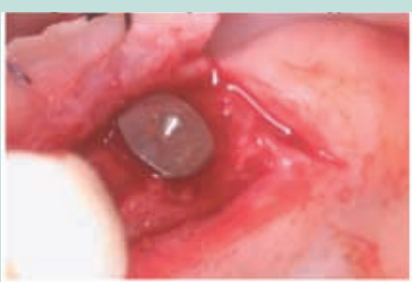
5

This was not dissimilar to the approach that Shadi used on his patient when we had the live link at the Users Meeting this year.
