Case Study No. 2

IAC restoration of an upper central incisor using the new metal impression post - Geoff Pullen

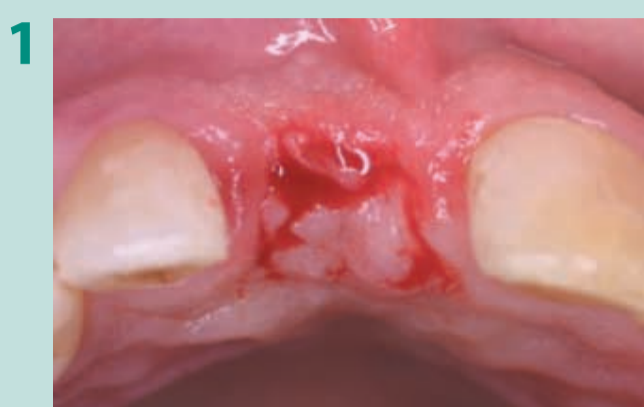
A U-shaped incision at second stage can be useful to avoid scarring in the interdental papillae. But no matter how much I think the crestal part is palatal enough, it usually isn't. Watch.

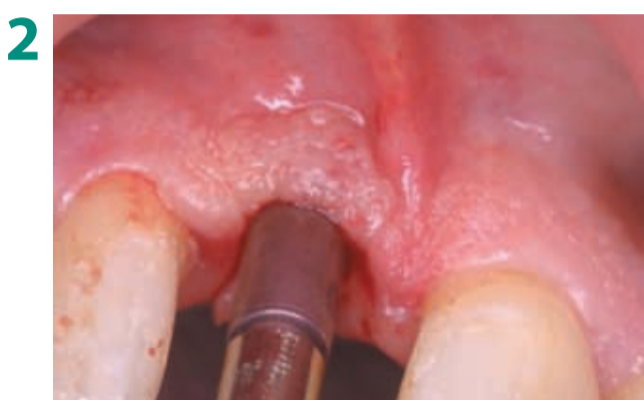
As I use the sulcus reamer, the gingival margin gets pushed both buccally, but more critically, apically. The crestal cut needed to be 1mm further to the palatal. It's a detail but 'could have been better.'

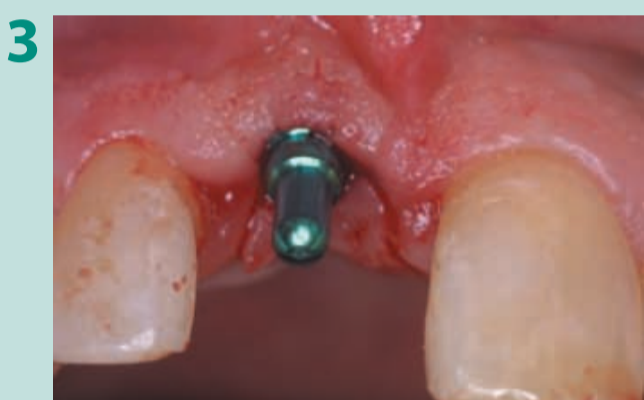
The new 3mm impression post comes in two parts. The metal post is pushed hard into the implant and the plastic part snaps over the top.

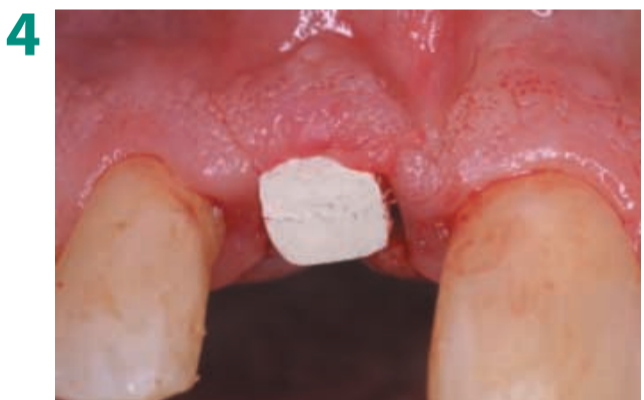
No need for sutures. Let's see what the crown looks like after 3 weeks.

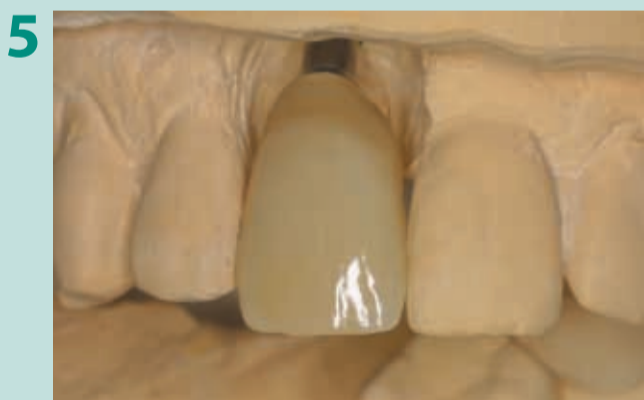
Here's the IAC on the model. The space is a little wide for the correct size tooth.

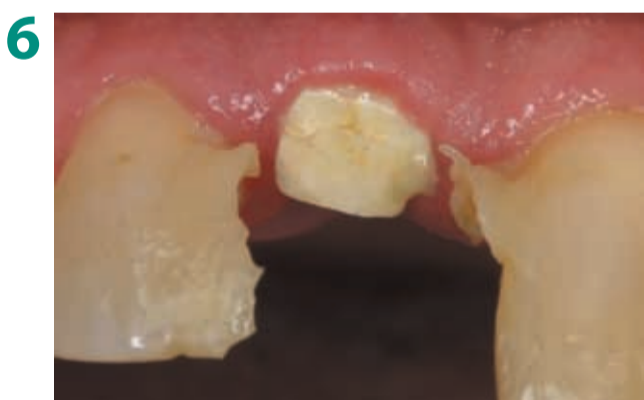
Bonded provisional removed. This takes quite a while to clean up so don't bond it with too much material after taking the impression or make sure the colour of the composite makes removal obvious.

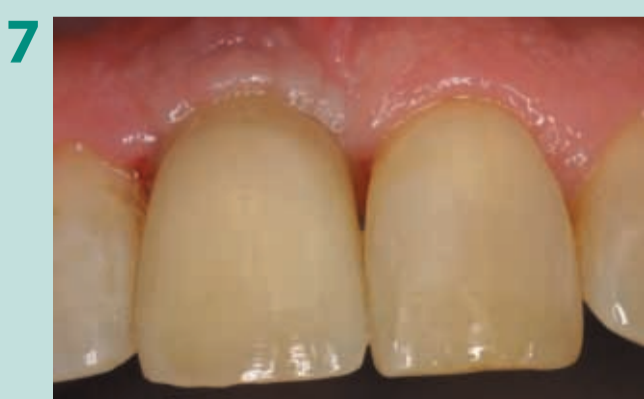
The finished result. Not bad. Could be better, could be worse, but the patient's delighted.
